Product Bulletin # TDS-266 Rev 1

# Blower Deflector Inspection

Canrig Top Drive models C500-681, C500-865, C750-681, and C750-865.

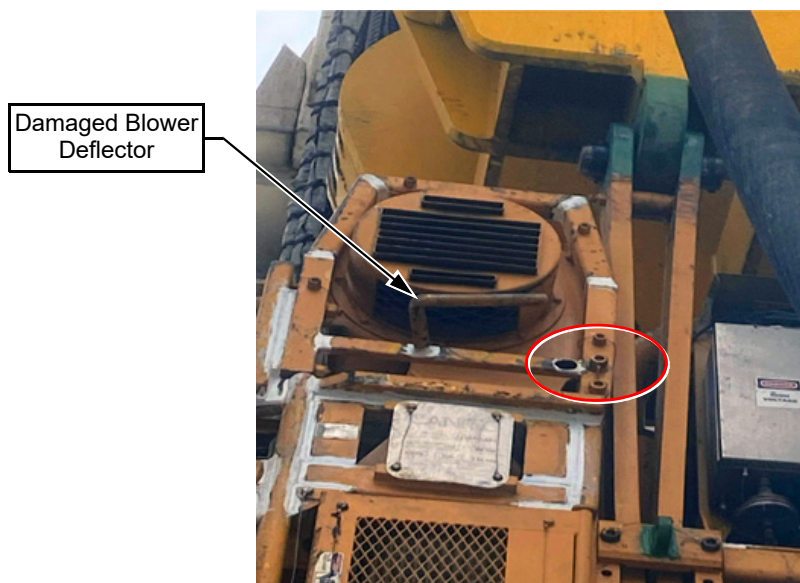
Canrig has become aware of an incident in which the blower deflector became entangled with a cable, and part of it became detached. The incident is still under investigation to determine the exact cause.

Figure 1: Damaged Top Drive Blower Deflector

- Visually inspect the blower deflector and the guard structure for any damage or deformation.
- Visually check for cracks in the welds.
- Repair or replace any damaged components.
