Product Bulletin # CDS-011 Rev 3

# CDS Link Tilt operations with Stabilizer Kit and Coupler Plate Mount

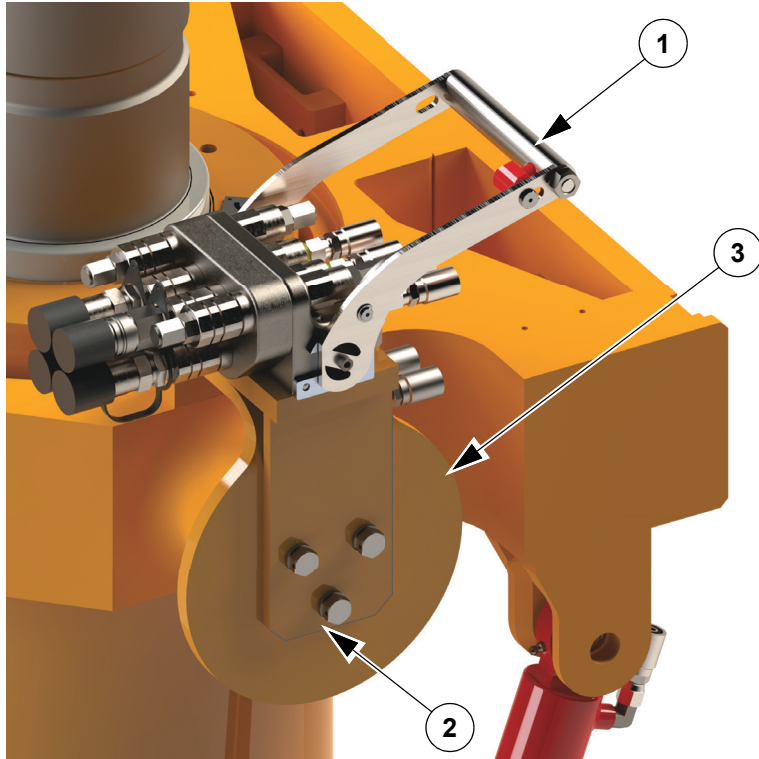
Figure 1: CDS link tilt assembly

1. Disassemble Single Joints Links Stabilizer Kit #5104015 from the CDS Link Tilt Assembly.
2. Disassemble the Multi Coupler Plate #H16763 (1), Mount #DT24294 (2) and Guard #16062 (3) from the CDS Link Tilt Assembly (Driller's Side):

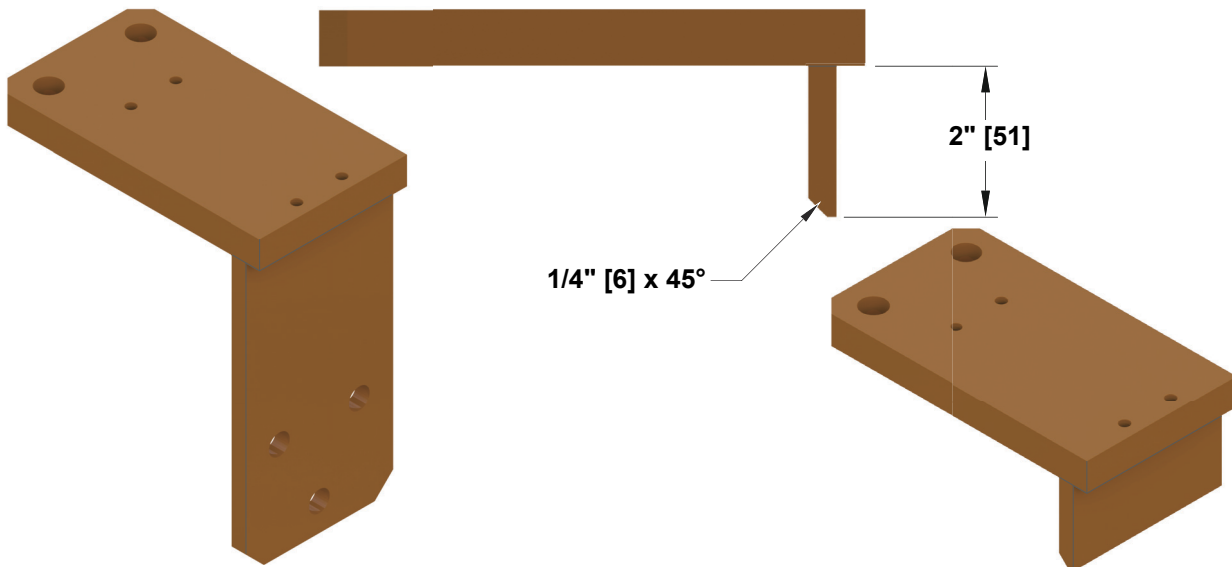
Figure 2: Modified mount

3. Modify Coupler Plate Mount #DT24294 to #DT24294M:

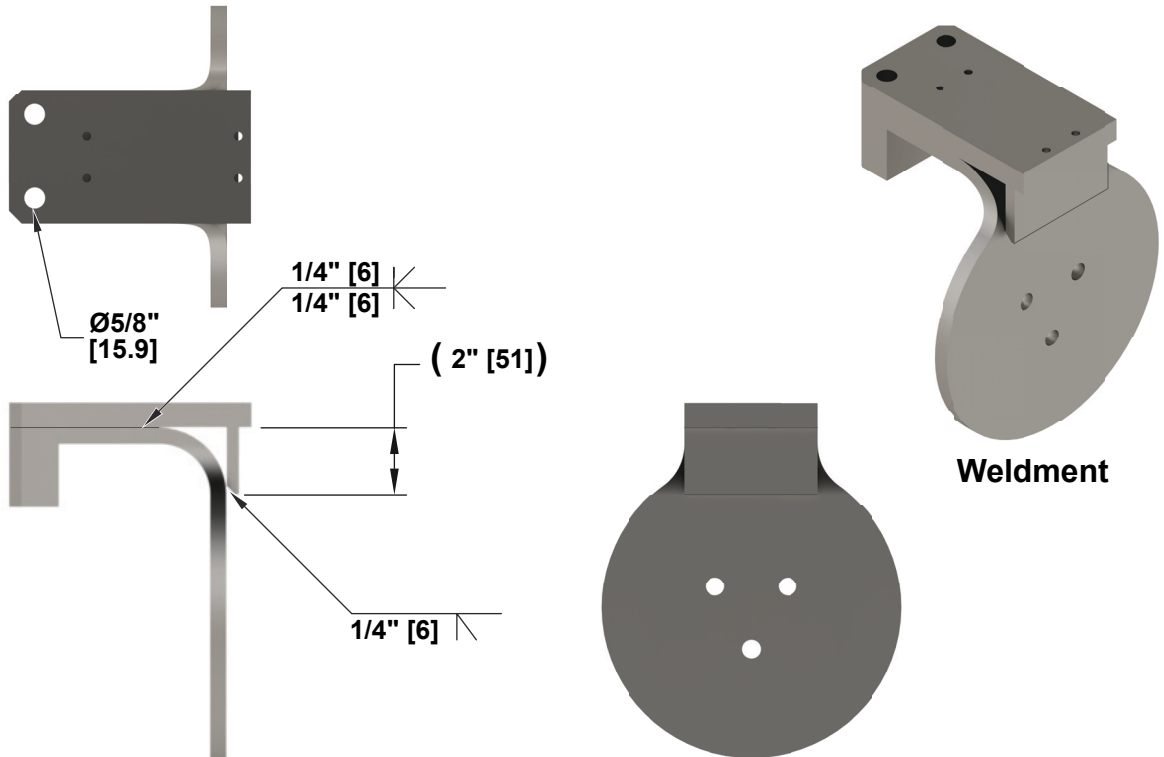
Figure 3: New mount weldment

- Remove paint from modified Coupler Plate Mount #DT24294M and Guard #16062 and prepare for welding.
- Weld the modified Coupler Plate Mount #DT24294M to Guard #16062; Ensure the components' two (2) 5/8" holes are aligned:

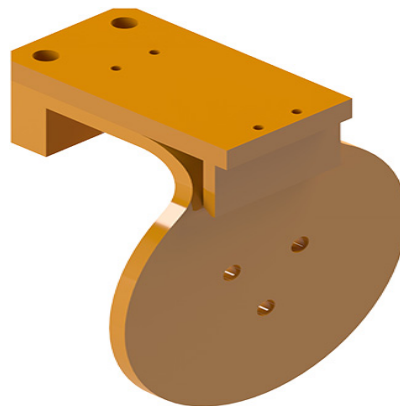
Figure 4: Mount Painted

- Paint the modified Guard #16062M (c/w welded modified Coupler Plate Mount #DT24294M) Tesco Yellow as per ENG713.

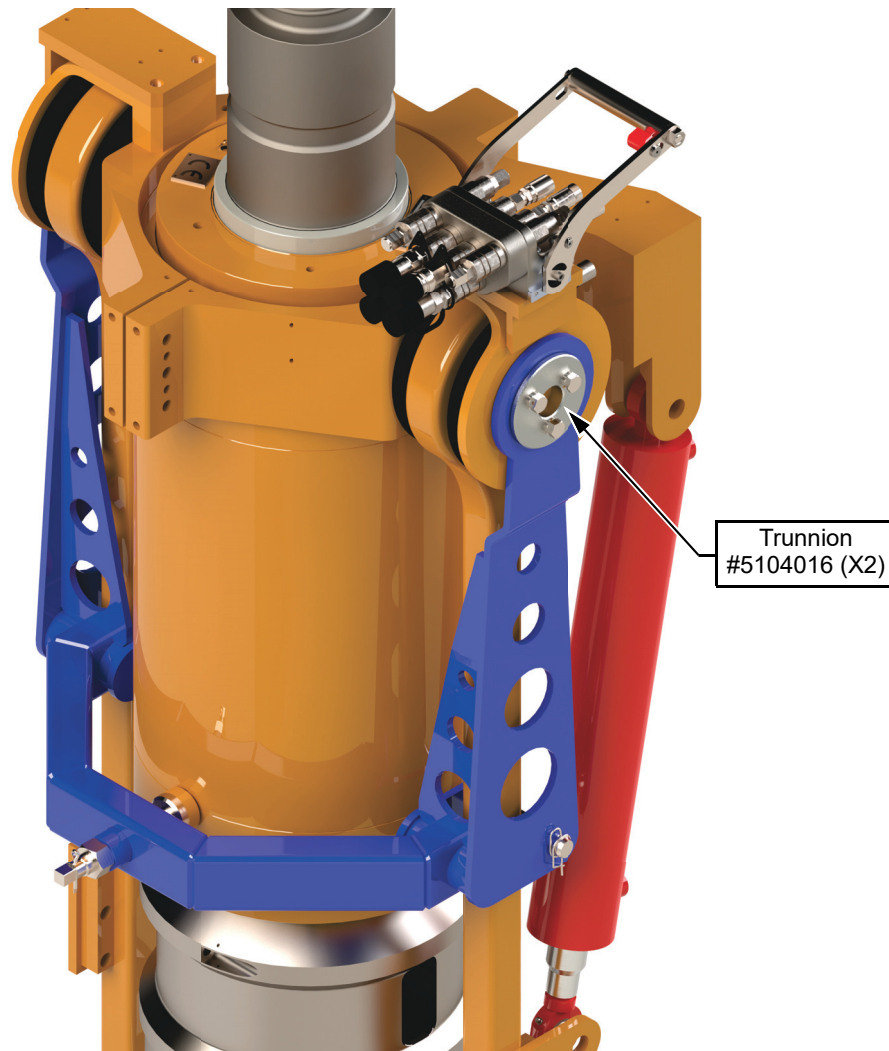
Figure 5: Guard and kit assembled to link tilt

7. Install the modified Guard #16062M & H16763 Multi Coupler Plate to the CDS Link Tilt Assembly.
8. Re-install Single Joints Links Stabilizer Kit #5104015 to the CDS Link Tilt Assembly:

Use #9012 Hex-Head Cap Screws, 1/2"-13 UNC × 2-1/4", Gr 8, Pld, Drilled Head (or equivalent) and Washers #5033127 to mount Trunnions #5104016. Torque the screws to 80 ft-lb and secure with lock wire.

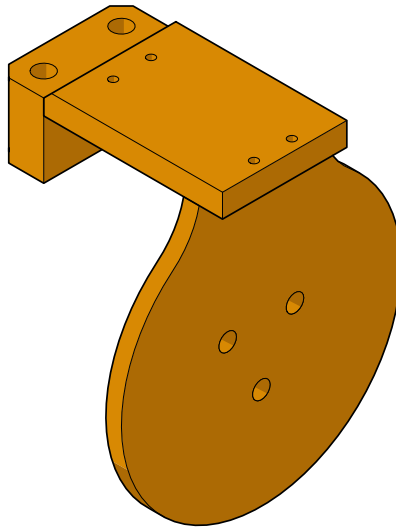
Figure 6: 5105106 Brace

Mount #DT24294 (Qty. 2) and Guard #16062 (Qty. 3) may be replaced by ordering and installing the current Brace #5105106.

Brace #5105106 installation requires:

- Screws #16327 (Qty. 2), Washers #17609 (Qty. 2).
- Screws #9012 (Qty. 3)(or equivalent) & Washers #5033127 (Qty. 3) to mount Trunnions #5104016.

Torque the screws to 80 ft-lb and secure with lock wire.
