Model: CDS  
Serial #: N/A

Product Bulletin # CDS-012 Rev 1

## Replacement of Coupler Plate Mount with Brace for CDS Link Tilt Operations With Stabilizer Kit

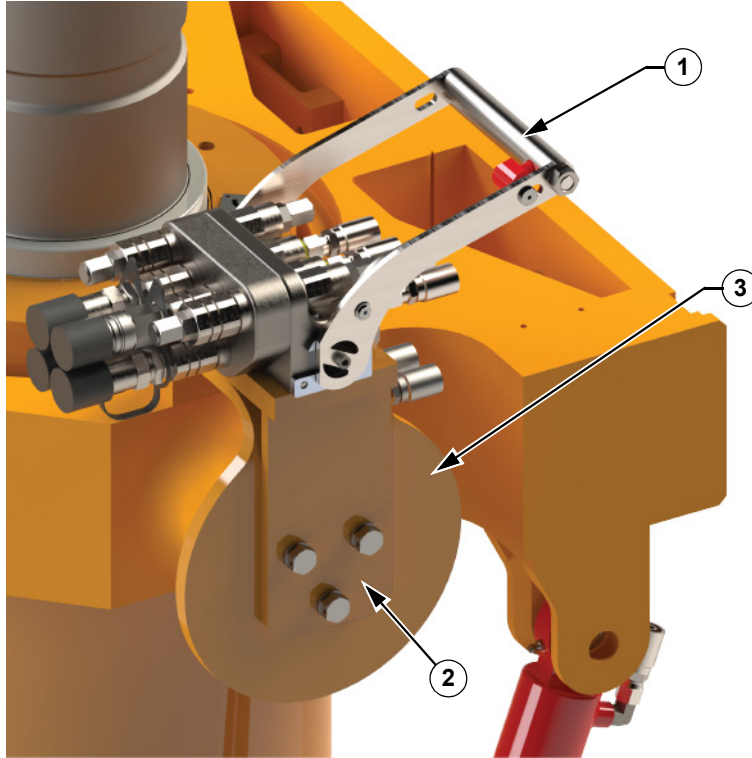
Figure 1: Guard, Mount and Multi Coupler View

2. Disassemble the Multi Coupler Plate #H16763 (1), Mount #DT24294 (2) and Guard #16062 (3) from the CDS Link Tilt Assembly (ODS side only):

3. Discard the #DT24294 (2), ODS Guard #16062 (3) and their fasteners.

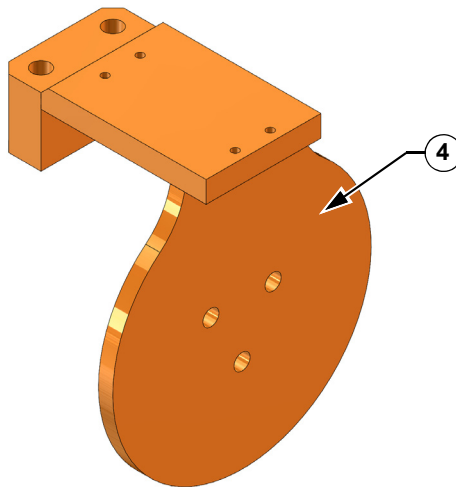
Figure 2: Brace

4. Install Brace #5105106 (4) with fasteners – top side only.

- 2x Washer, Lock, Helical Spring, 1/2", Alloy, Pld #5881 (5).
- 2X Screw, Cap, Hex Hd, 1/2"-13UNCx3-1/2", Gr8, Pld, Dr Hd #16327 (6).
- Apply Lock Wire.

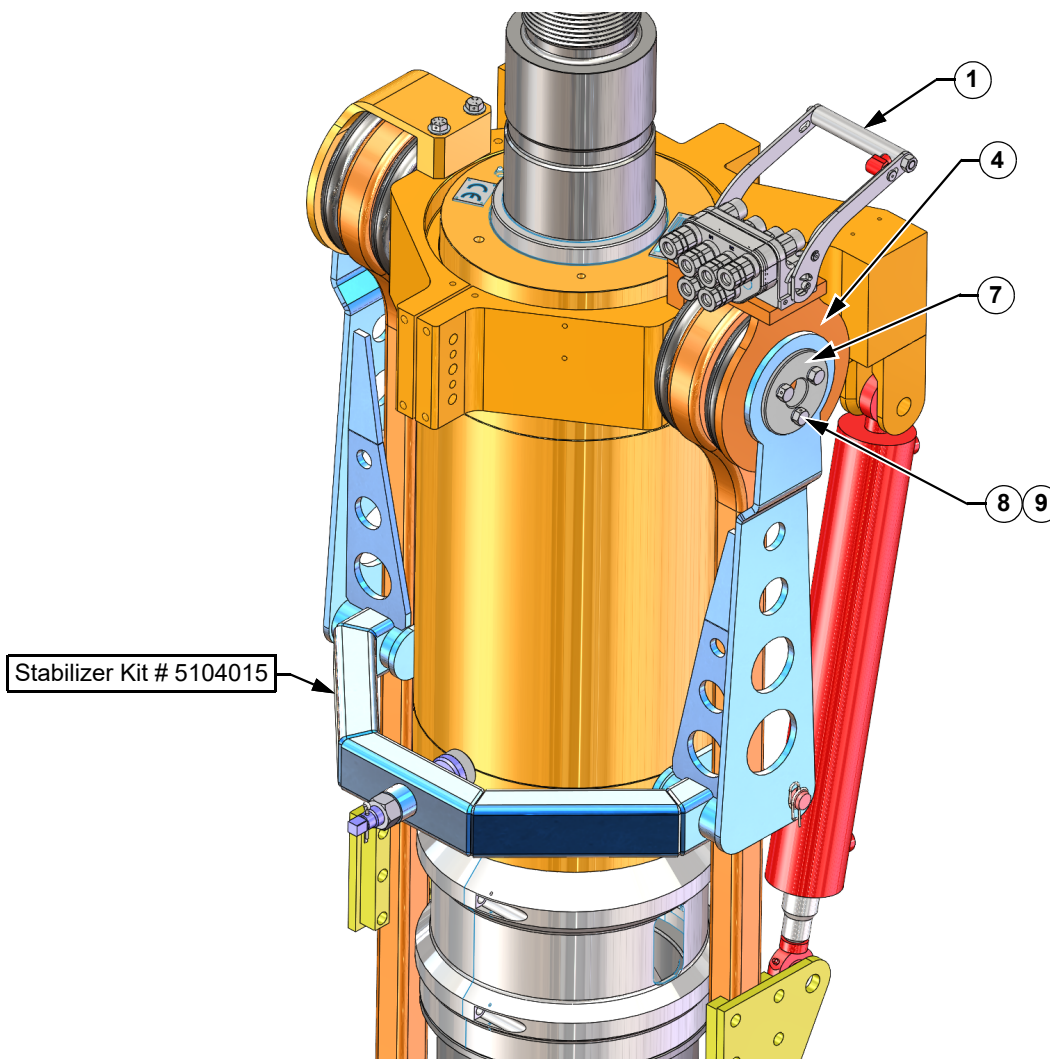
Figure 4: Brace, Multi Coupler and Stabilizer Kit view

5. Install the H16763 Multi Coupler Plate (1) to the Brace (4) by re-using its fasteners:
  - 4x Lockwasher, 1/2 Nord-Lock #LW-0500-NL.
  - 4X CAPSCR, HEX SOC HD, 5/16-18UNC x 2.50, W #SH-0312NC-0250-W.
  - Apply Lock Wire.
6. Re-install Single Joints Links Stabilizer Kit to the CDS Link Tilt Assembly as per #5104015 Assembly Drawing:

Ensure the screws used to mount Trunnions #5104016 are compliant with 9012 Screw, Cap, Hex Hd, 1/2"-13UNC x 2-1/4", Gr 8, Pld, Dr Hd, torqued to 80 ft-lb and lock wired.
